Reliability Assessment: City of Olmos Park

Report Date: 10/15/2021

Customer: City of Olmos Park via City Manager Celia Deleon

Report Prepared by: Justin Bisignano with assistance from GIS Support and Reliability
Department

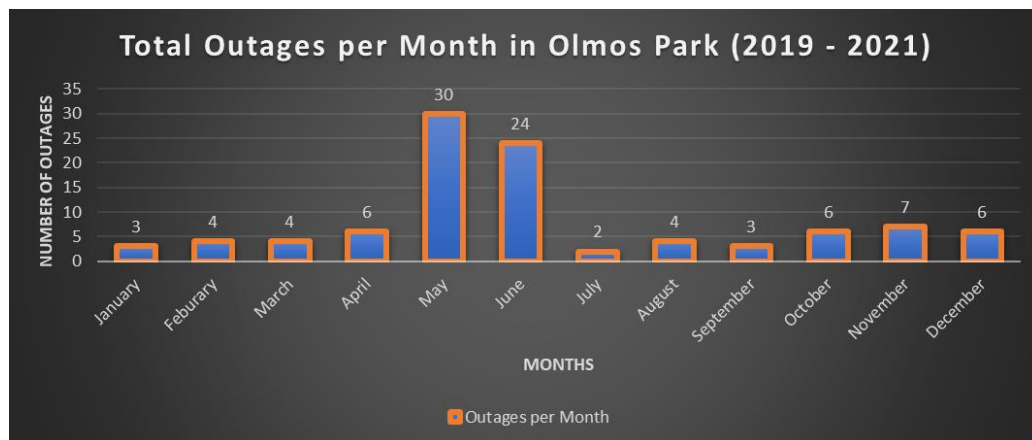
Figure 1: Total Outages per Month in Olmos Park (2019 – 2021)

City of Olmos Park is powered by three separate circuits that also span to adjacent cities bordering Olmos Park. An analysis of two years' worth (6/01/2019 – 6/01/2021) of outage history data was reviewed to determine outage causes and trends. The initial observations from the outage history data shows 2019 has had the most outages within the last two years. The outage history data shown in figure 1 below depicts how many outages in total were sustained by month within the two-year range. Figure 1 below also shows that May, June, and November are the months that have sustained the most outages throughout the two-year period being investigated. These three months with the most outages coincide with the data from figure 2 below. Figure 2 below shows the percentage of the outage causes experienced by Olmos Park. From figure 2, 40.4% of the outages sustained were the result of inclement weather. The second most common outage was trees totaling at 28.2%. CPS Energy equipment failure should also be considered when factoring inclement weather and trees as outage causes. Most overhead CPS Energy equipment is damaged from severe weather and overgrown trees. These three-outage cause's total of 74% of all the outages experienced by Olmos Park within the last two years. The data from figure 1 coincides with the data from figure 2 due to the type of weather experienced in the months of May, June, and November.

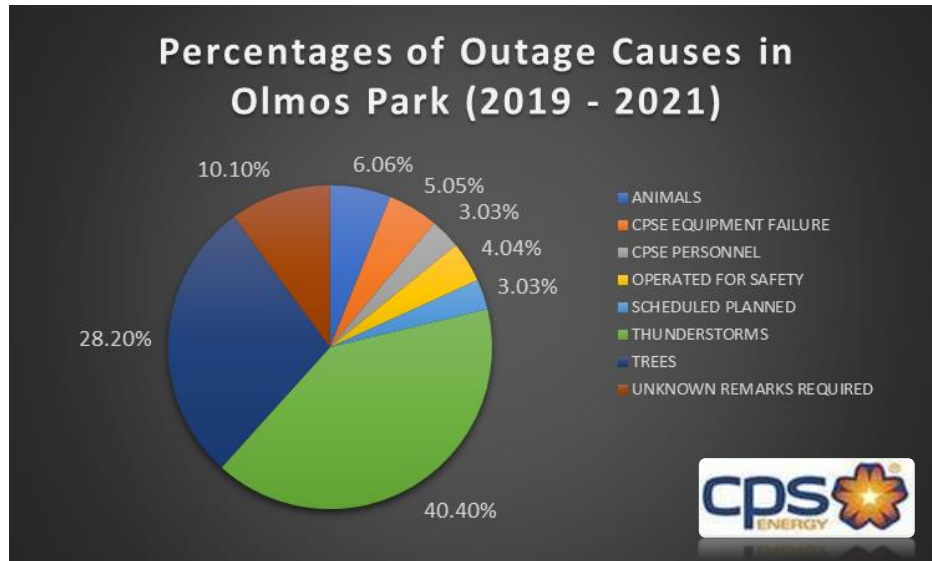
Figure 2: Percentage of Outage Causes in Olmos Park (2019 – 2021)

Over the course of the past five years the City of Olmos Park has had tree trimming within four regions throughout the city shown in figure 10 below. The City of Olmos Park is powered by roughly 89% of overhead power lines and the remaining 11% underground power lines. Overhead power lines are susceptible to inclement weather and outside forces such as tree interference and lightning strikes. As noted in figure 2 above 68.6% of the outages in Olmos Park are the result of inclement weather and tree interference.

CPS Energy analyzed available outage, infrastructure, and vegetation data for the City of Olmos Park to assess the reliability for the residents of this area. The outage causes experienced in Olmos Park help to define what and where the problem areas are and where to begin looking. From figure 2 above 68.6% of all the outages sustained in Olmos Park in a two-year period are the result of inclement weather and trees. Olmos Park is a heavily forested area with trees being difficult to access for tree trimming efforts. CPS Energy will issue a full circuit patrol to identify overgrown vegetation to help reduce the number of outages experienced by the City of Olmos Park. Collaboration between CPS Energy and the City of Olmos Park to address vegetation will help improve reliability for the citizens residing within Olmos Park.

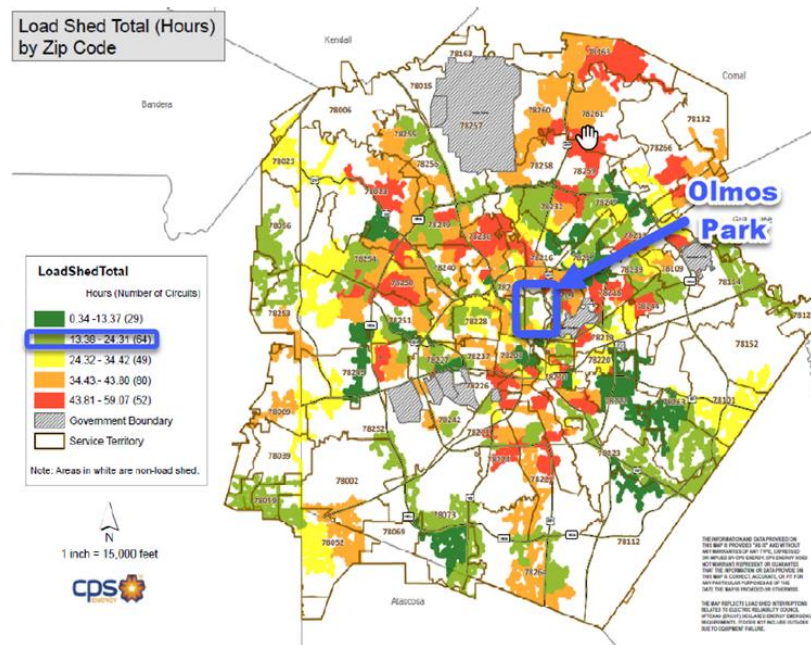
Figure 3: Load Shed Map by Zip Code for outages experienced from Winter Storm Uri (Referenced *CoSA Community Emergency Preparedness Committee Report*)

Olmos Park is powered by three separate circuits to diversify and sectionalize how Olmos Park receives electricity. During Winter Storm Uri only one of the circuits powering Olmos Park experienced rolling blackouts to accommodate for shedding load. The circuit that experienced outages due to Winter Storm Uri had outages on February 15th and 16th. The residents receiving power from the circuit experiencing outages from Winter Storm Uri were without power for a total of 24 hours non-consecutively. Roughly 273 residents out of a total of 1173 residents in Olmos Park experienced outages from Winter Storm Uri. Figure 3 below shows the load shed by zip code experienced from Winter Storm Uri. Figure 3 below helps compare what residents experienced from Winter Storm Uri to San Antonio as a whole.

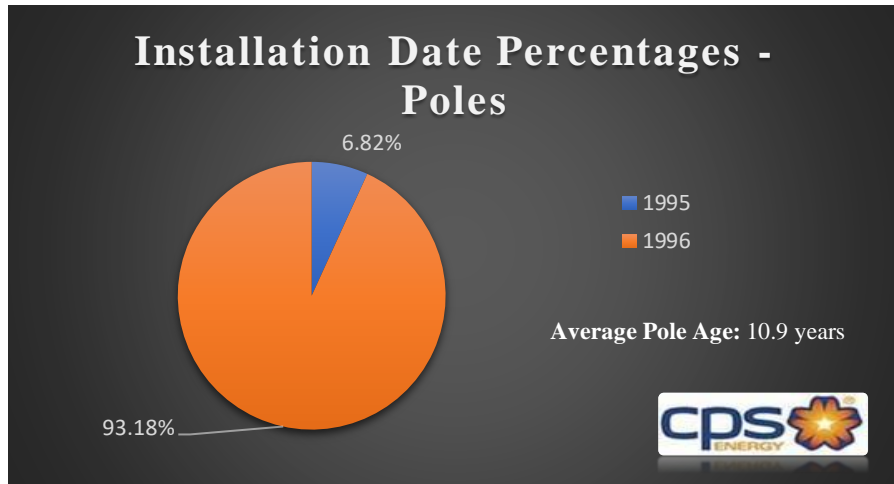
Figure 4: Installation Date Percentages for Support Structures (Poles) in Olmos Park

There is a total of 264 support structures (poles) throughout the City of Olmos Park. The support structures are incrementally placed and are responsible for holding power lines and other CPS Energy equipment. To determine the status of the infrastructure within Olmos Park the age of the support structures (poles) was analyzed. The data shown in figure 4 below depicts the installation date percentages of the support structures in Olmos Park. Roughly 93% of all the support structures in Olmos Park were installed from 1996 onward while the remaining 7% of the poles were installed on or prior to 1995. After inspecting the data further an average age of 10.9 years was observed out of the total number of support structures within Olmos Park shown in figure 4. The average age of the support structures within Olmos Park is well within the healthy lifecycle of wooden support structures.

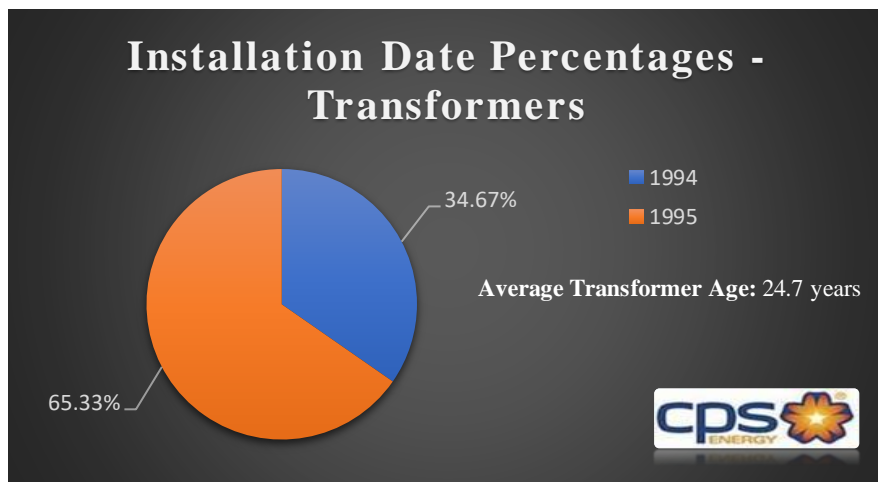
Figure 5: Installation Date Percentages for Transformers in Olmos Park

Transformers are devices that increase or decrease the voltage supplied to a customer or facility. There is a total of 398 transformers throughout the city of Olmos Park. A total of 96% of all the transformers in Olmos Park are on overhead power lines. The age of transformers was analyzed to help determine the status of the infrastructure within Olmos Park. The data shown in figure 5 below depicts the installation date percentages of the transformers in Olmos Park. Roughly 65% of all the transformers in Olmos Park were installed from 1995 onward while the remaining 35% were installed on or prior to 1994. From the same dataset an average transformer age of 24.7 years was observed out of the total number of transformers within Olmos Park shown in figure 5. Roughly 65% of the transformers in Olmos Park have an average age that is halfway through a transformer’s lifecycle. While the remaining 35% are within the later stages of a transformer’s lifecycle. However, the transformers within Olmos Park have not shown signs of distress or malfunctions.

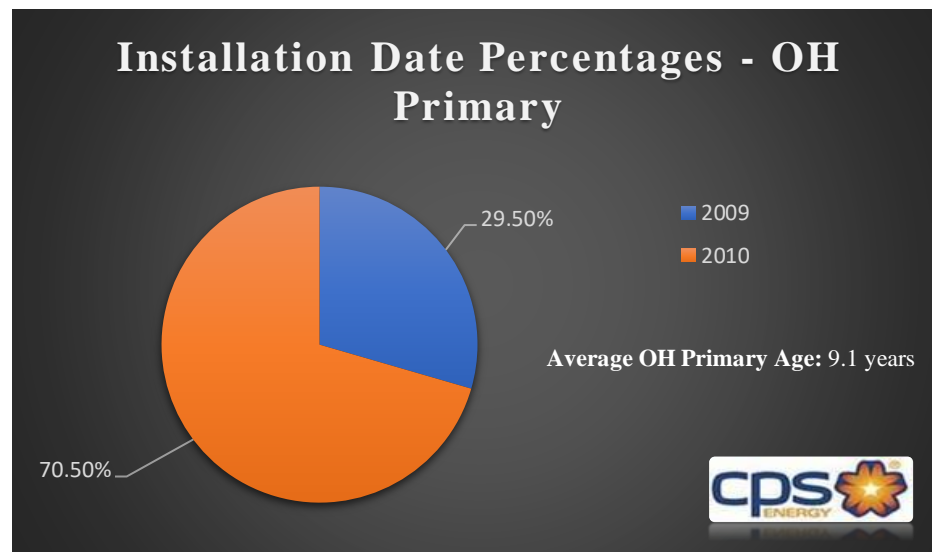
Figure 6: Installation Date Percentages for Overhead (OH) Primaries in Olmos Park

The third piece of equipment to determine the status of the infrastructure in Olmos Park is the age of the overhead and underground power lines that supply Olmos Park. Figure 6 below depicts the installation date percentages of the overhead power lines. Roughly 70% of the overhead power lines in Olmos Park were installed 2010 and onward and the remaining 30% were installed on or prior to 2009. Out of the total overhead power lines an average age of 9.1 years was observed. Figure 7 below depicts the installation date percentages of underground power lines. Roughly 67% of the underground power lines in Olmos Park were installed 2010 and onward and the remaining 33% were installed on or prior to 2009. Out of the total underground power lines an average age 8.2 years was observed. The industry standard lifespan of overhead power lines is 40 years while underground power lines are 35 years. A large majority of both overhead and underground power lines are within a healthy lifespan for coaxial power cables.

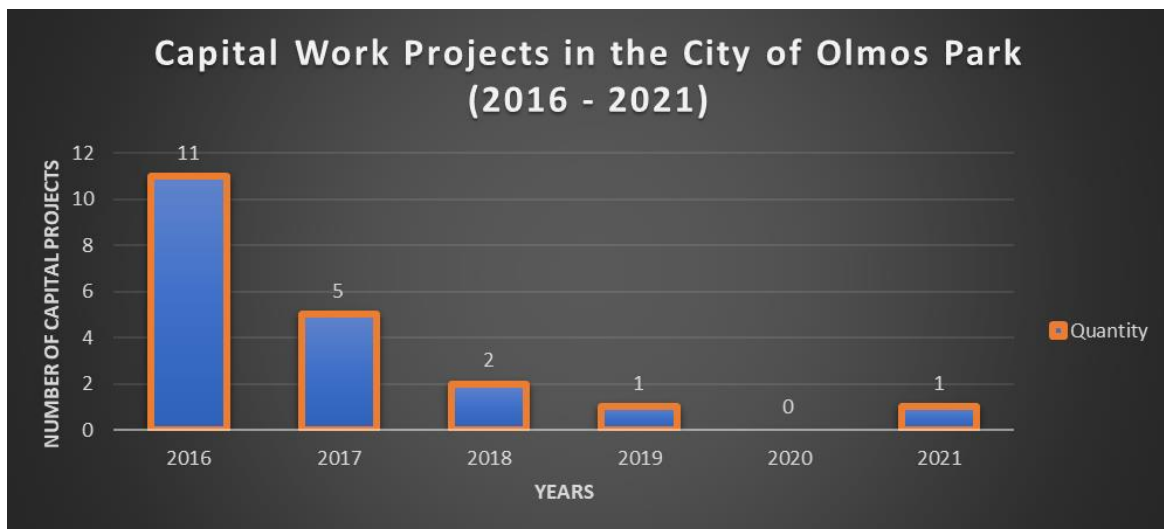
Figure 8: Totals of Capital Infrastructure Work in Olmos Park (2016 – 2021)

Capital projects range in size from installing a single piece of equipment to large scale infrastructure updates to improve reliability or adjust for growth. In 2016 there was a total of 11 capital projects started in Olmos Park shown below in figure 8. Most of the projects started in 2016 were pole replacements. For example, 7 out of the 11 projects conducted in 2016 were pole replacements. A total of 50 poles were replaced to update existing infrastructure. The remaining projects started in 2016 were installing circuit protection equipment, rerouting circuits to adjust for growth, and adjusting CPS Energy equipment for new streetlights.

In 2017 there was a total of five capital projects started in Olmos Park shown below in figure 8. To adjust for growth such as apartment complexes or new businesses in Olmos Park, 3 out of the 5 capital projects were rerouting of current circuits for both overhead and underground power lines. A voltage regulator bank was installed in Olmos Park to assist in maintaining a constant voltage. A voltage regulator bank will help ensure customers in Olmos Park will have power in the event the substation has a sag in voltage.

In 2018 there was a total of two capital projects started in Olmos Park shown below in figure 8. The first capital project undertaken in Olmos Park was the installation of a circuit protection equipment to improve reliability for customers in Olmos Park. The second capital project started in 2018 was the St. Mary's Street Project. The St. Mary's street project was started to adjust for growth in the area. The infrastructure changes are along St. Mary's street starting from E. Mistletoe street to W. Josephine street. This project replaced some of the poles in the area and moved existing poles to better adjust for the growth. The St. Mary's Street Project is also responsible for the capital project undertaken in 2019. The capital project starting in 2021 will add circuit protection equipment to improve customer reliability. The circuit protection equipment being installed in 2021 was the result of the previous reliability assessment conducted for the City of Olmos Park this year.

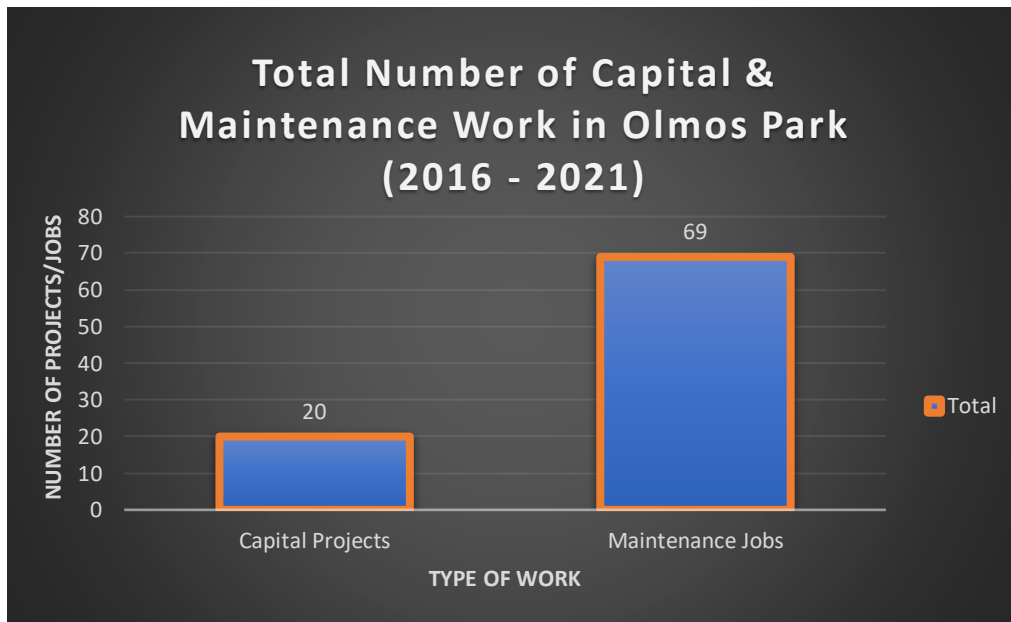
Figure 9: Total's of both Capital Projects & Maintenance Jobs in Olmos Park (2016 – 2021)

Maintenance work is classified as any jobs to repair or replace existing infrastructure or faulty equipment. Within the past five years (2016 – 2021) there has been a total of 69 maintenance jobs within Olmos Park. Most of these jobs were to replace equipment such as lightening arrestors and crossarms to name a few. Lightning arrestors are circuit protection equipment placed on critical equipment to protect them from possible lightning strikes. Crossarms are the wood bars on the top of poles that hold the power lines in place. Figure 9 below shows the total number comparison between capital projects and maintenance jobs. Capital projects are much larger in scale which is why there are fewer capital projects when compared to maintenance jobs in Olmos Park.

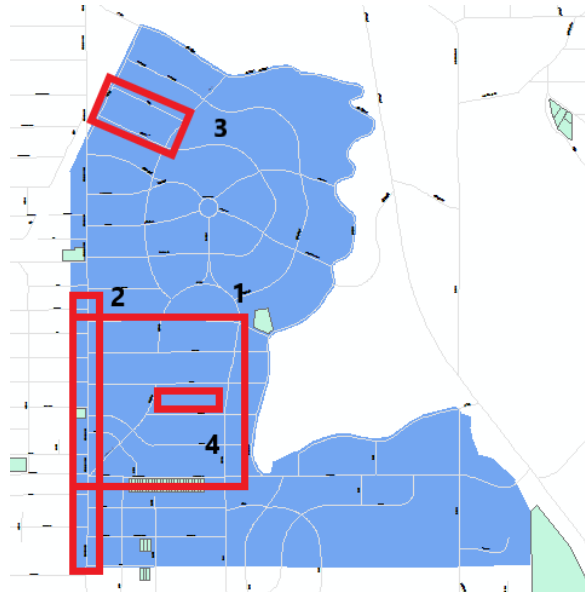
Figure 10: Tree Trimming & Maintenance Locations in Olmos Park

Olmos Park is a heavily forested area with overhead power lines located in difficult to access areas. Two areas have been identified to have some outstanding vegetation and are in the process of being trimmed to improve reliability. Section 1 in figure 10 below trees were located and addressed in 2017 along Parklane Dr, Stanford Dr., Luther Dr., Belvidere Dr., Primera Dr., and E. Olmos Dr. Section 2 shown in figure 10 had tree trimming maintenance completed along McCullough Ave. in 2018 to address trees interfering with power lines. Section 3 in figure 10 trees were located and planned for tree trimming between Belvidere Dr. and Luther Dr. Finally, Section 4 in figure 10 trees were located and trimmed the segment between Paloma Dr. and E. Mandalay Dr. Both Section 3 and 4 are the most recent occurrence of trees interfering with power lines and CPS Energy equipment. In addition to the tree trimming maintenance six damaged crossarms were replaced in August 2018.

- Tree Trimming Maintenance was conducted in January 2017 along Parklane Dr, Stanford Dr., Luther Dr., Belvidere Dr., Primera Dr., and E. Olmos Dr.

- Tree Trimming Maintenance was conducted in August 2018 along McCullough Avenue to address trees interfering with power lines and CPS Energy equipment.
- Six Crossarm replacements

- Tree Trimming Maintenance was conducted in August 2021 off Paloma Dr. & E. Mandalay Dr. to address trees interfering with power lines and CPS Energy equipment.

- Tree Trimming Maintenance is planned for October 2021 along Belvidere Dr. & Luther Dr.
