Olmos Park Questions & Responses

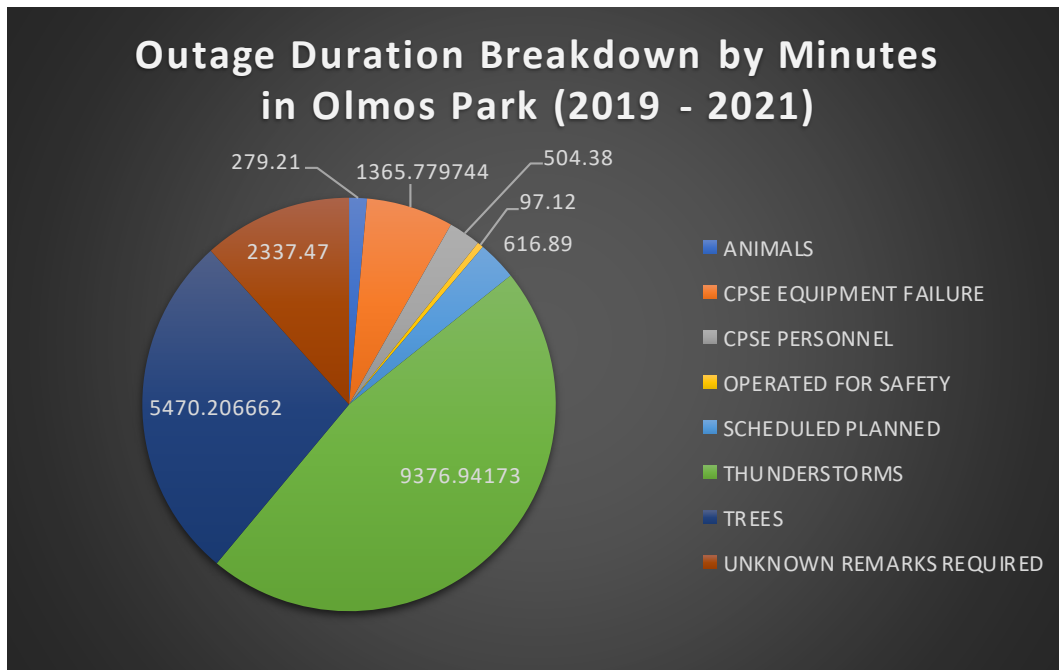
Remark: CPS Energy classifies outages by either momentary or sustained outages. A momentary outage is any outage that lasts five minutes or less while a sustained outage is any outage greater than five minutes. Figure 1 below shows the total outage duration breakdown in minutes for the different outage causes in Olmos Park. This data is consistent with inclement weather and trees causing a majority of the outages experienced in Olmos Park. Residents of Olmos Park experienced a total of 20,047 minutes without power over the course of the past two years. There is a total of 1,051,200 minutes over the course of two years. So roughly 1.9% of the total time of the past two years was spent without power by Olmos Park residents. Please note that when an outage occurs not every person in Olmos Park would be without power. CPS Energy sectionalizes circuits to ensure when an outage occurs a minimal number of customers will experience an outage.

Figure 1: Outage Duration Breakdown by Minutes in Olmos Park (2019 – 2021)

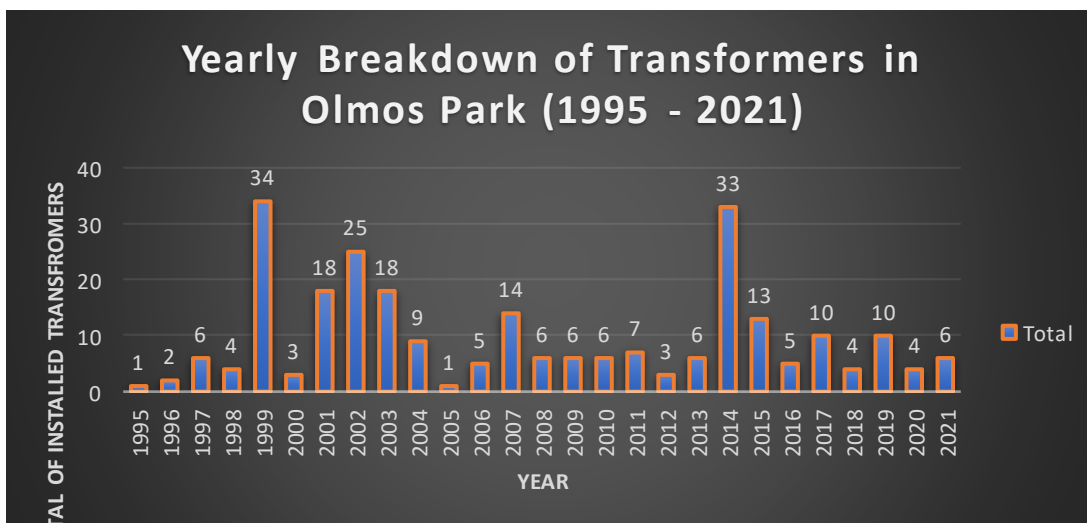
Remark: CPS Energy accounts for a life expectancy of 50 years for transformers. Figure 2 below shows the yearly breakdown of transformers installed on and after 1995. A total of 259 transformers were installed from 1995 onward out of the 398 total transformers within Olmos Park. Please note that CPS Energy monitors our equipment (including transformers) for signs of distress, failure and growth in an area. Transformers are replaced as needed based on performance issues encountered in the field or during our routine monitoring and inspections.

Figure 2: Yearly Breakdown of Transformers Installed in Olmos Park (1995 – 2021)
